Reliability improvements on high speed reciprocating compressors through bearing and process modifications

- Case Study

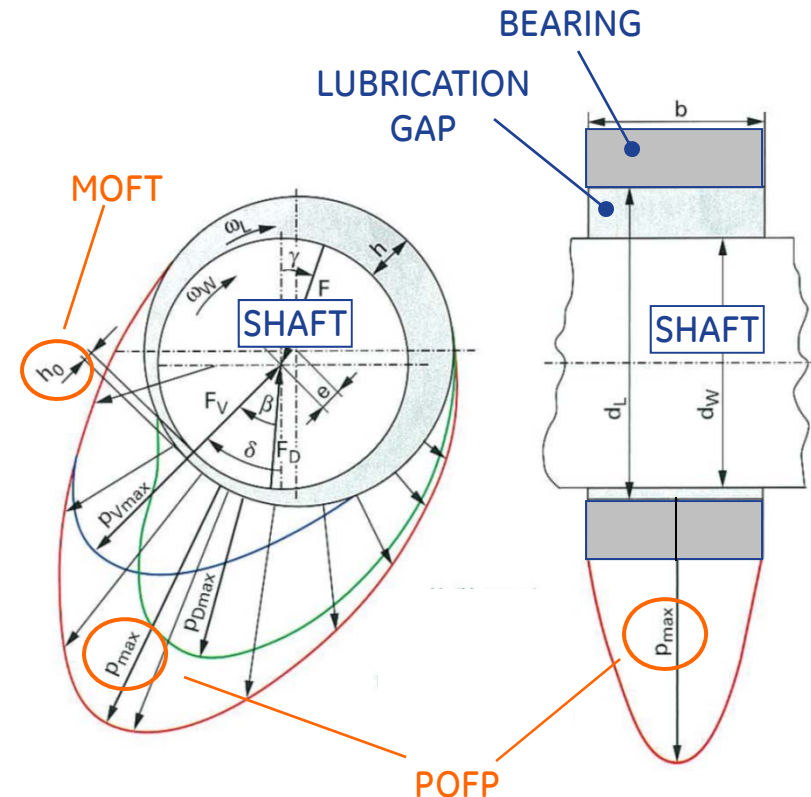
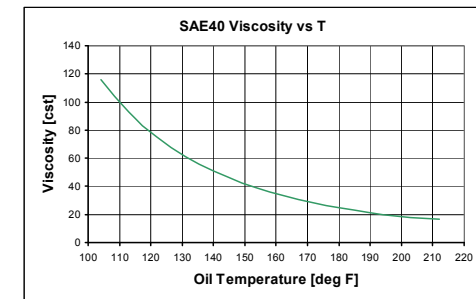
Bearing operating principle

- The reciprocating motion of the shaft generates a variable lubrication film thickness: the pin changes its position both circumferentially and radially
- The geometry of the bearing gives a pressure trend within its width

Bearing performance

- To avoid rapid bearing wear:
 - Adequate separation between moving components (↑ MOFT)
 - Low stress level (↓ POFP)

Bearing design criteria

- Wide bearing surface to ↓ POFP
- ↓ oil inlet T and ↑ cooling flux to ↑ oil viscosity and therefore ↑ MOFT

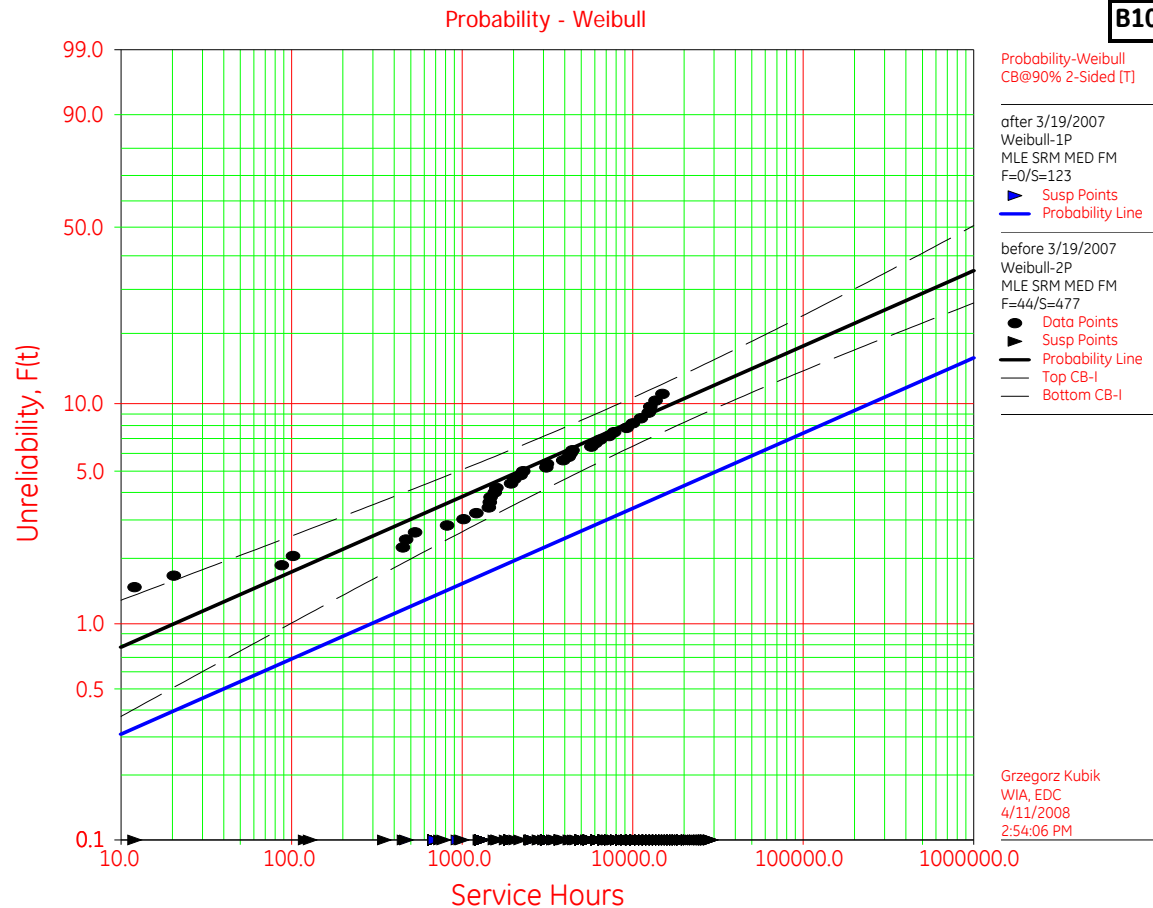
Bearing Weibull Analysis

Before 3/19/2007	After 3/19/2007
No of Failures	44	0
No of Suspensions	477	123
Beta	0.35	0.35
Eta	10,874,385	156,206,865
MTTF	55,268,030	794,239,601
B10	17,202	246,915

- Weibull analysis shows $\beta = 0.35$.
- This indicates an Infant Mortality failure mechanism.
- The units produced since Mar-2007 demonstrate **14 times improvement** in Reliability

after 3/19/2007: $\beta=0.3489, \eta=1.5621E+8$
before 3/19/2007: $\beta=0.3489, \eta=1.0874E+7$

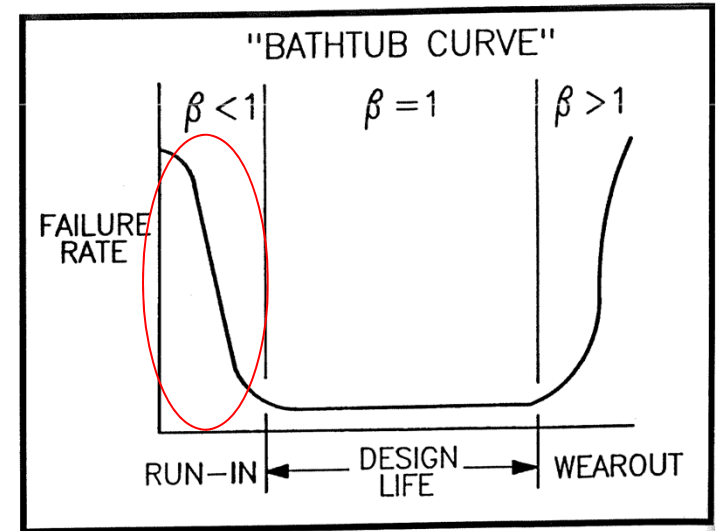
Weibull Interpretation

Beta	B10* Life (hrs)
Before improved Cleanliness	.35	17,638
After improved cleaning	.38	26,683
After New Bearing fit/ tab	.27	141,168
After New Factory Inspection	.37	1,691,771

*B10 is the prediction of non-failure of this mode for 90% or more

B10 says 'design life' fall-out is very low; Beta supports failure occurs early in life

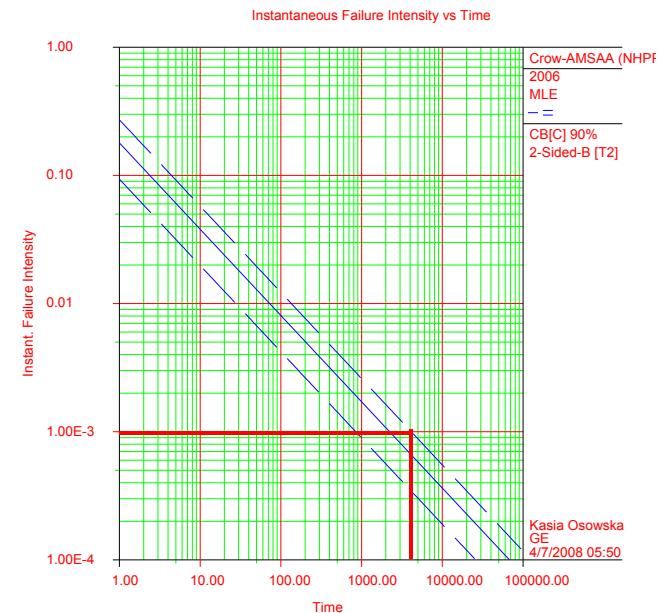
Detail: Crow AMSAA for 2006-ship Units...

for units operating >5000 hrs,

< 0.1% chance of failure in "design life" period (w/ 90% confidence)

Beta=0.3268, Lambda=0.5493

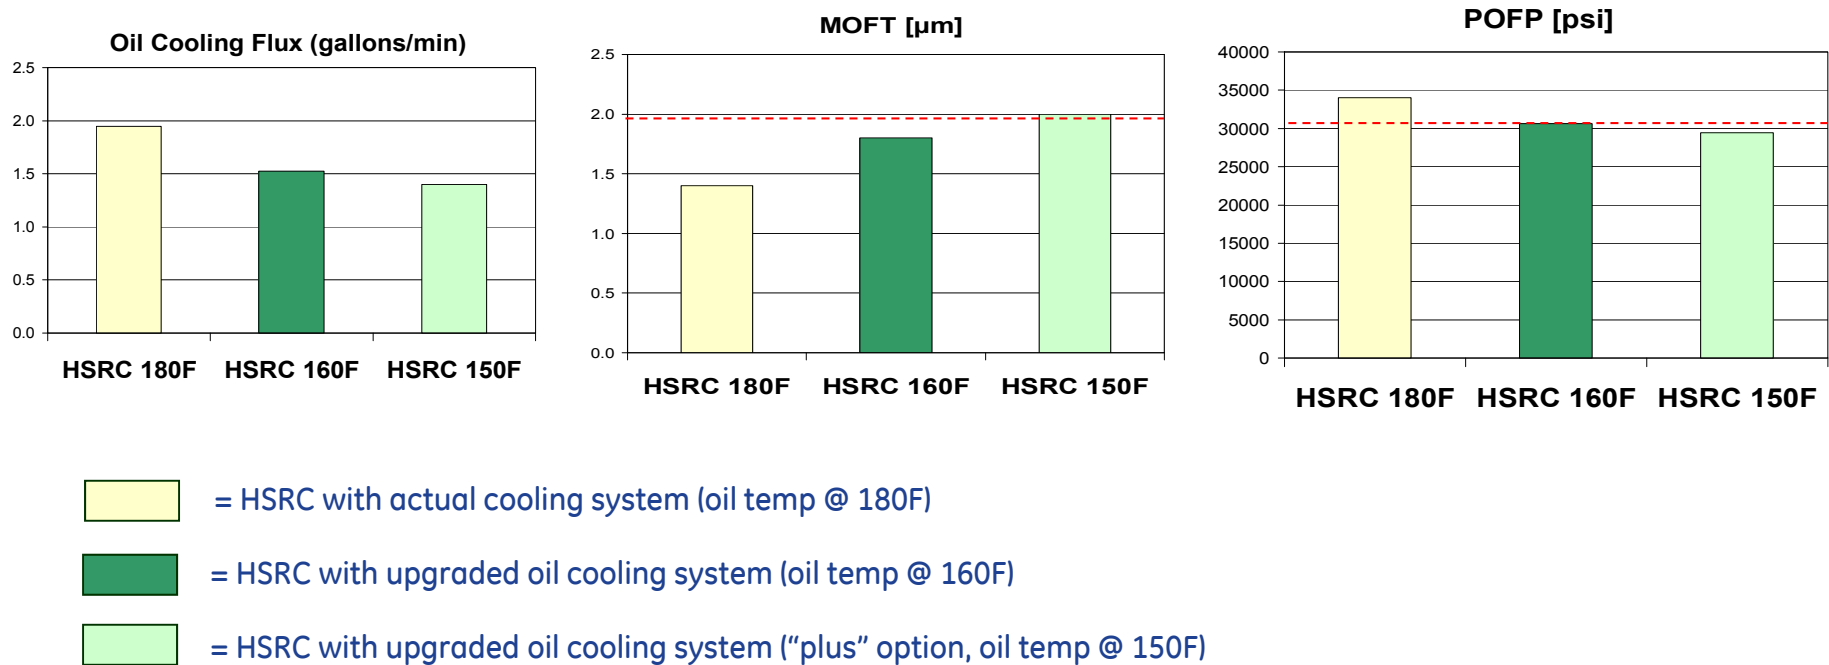
Bearing analysis – HSRC oil cooling effect

Oil delivery system robustness is key impact to managing good bearing parameters... poor oil control impacts other factors (when MOFT is low)

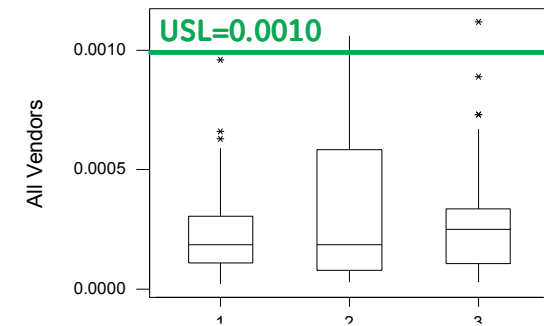
CS Parallel Mains

- Crankshaft geometry out of cylinder/
parallel ... key manufacturing CTQ with
suppliers
 - Main CS journals 'good'
 - **Crank journals – vendor variation**
'devil is in the details'
- Also, bearing fit into Conn Rod in the final
assembled condition a key to good journal
 - Conn Rod cap torque level and
machining are key
 - Bearing 'crush' and deflection key

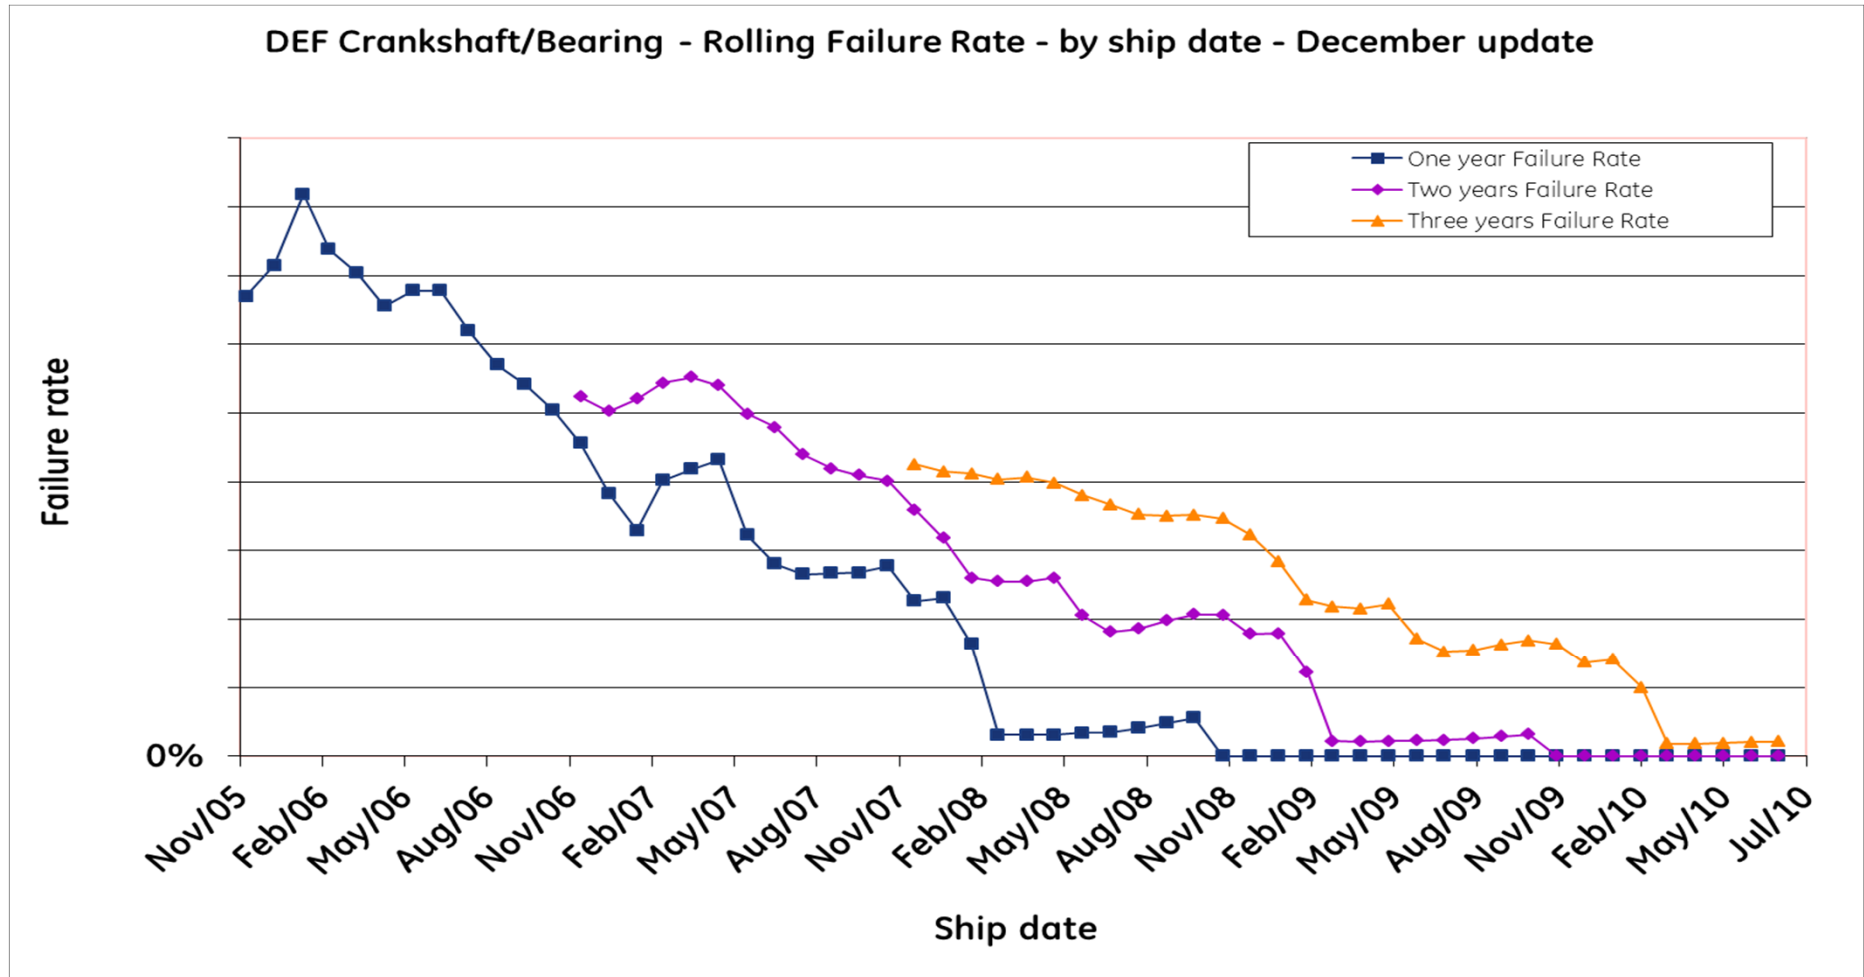
“DEF” Crankshaft/Bearing Rolling Failure Rate

- The last Crank end bearing failure occurred in units produced in Nov 2007.
- No failures since 3 years of shipment.

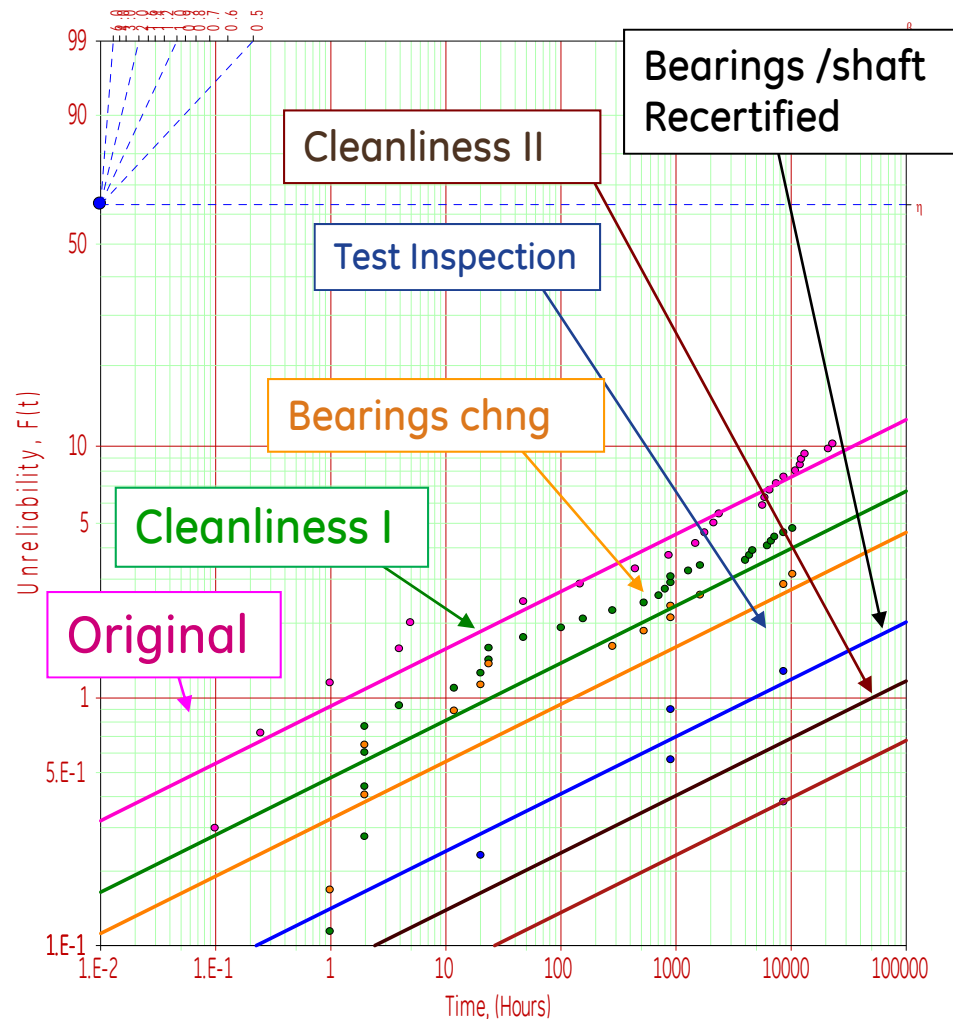
DEF Crankshaft/ Bearing-only Weibull

- Measurable Brg/ CS Reliability step improvement from '05-'08 ... **at three years (30 Khrs) : improved from >10% Failure Rate to < 0.5%**
- **No bearing failures on units shipped since November 2007...** *although some customers still limit bearings to ~ 2 years*

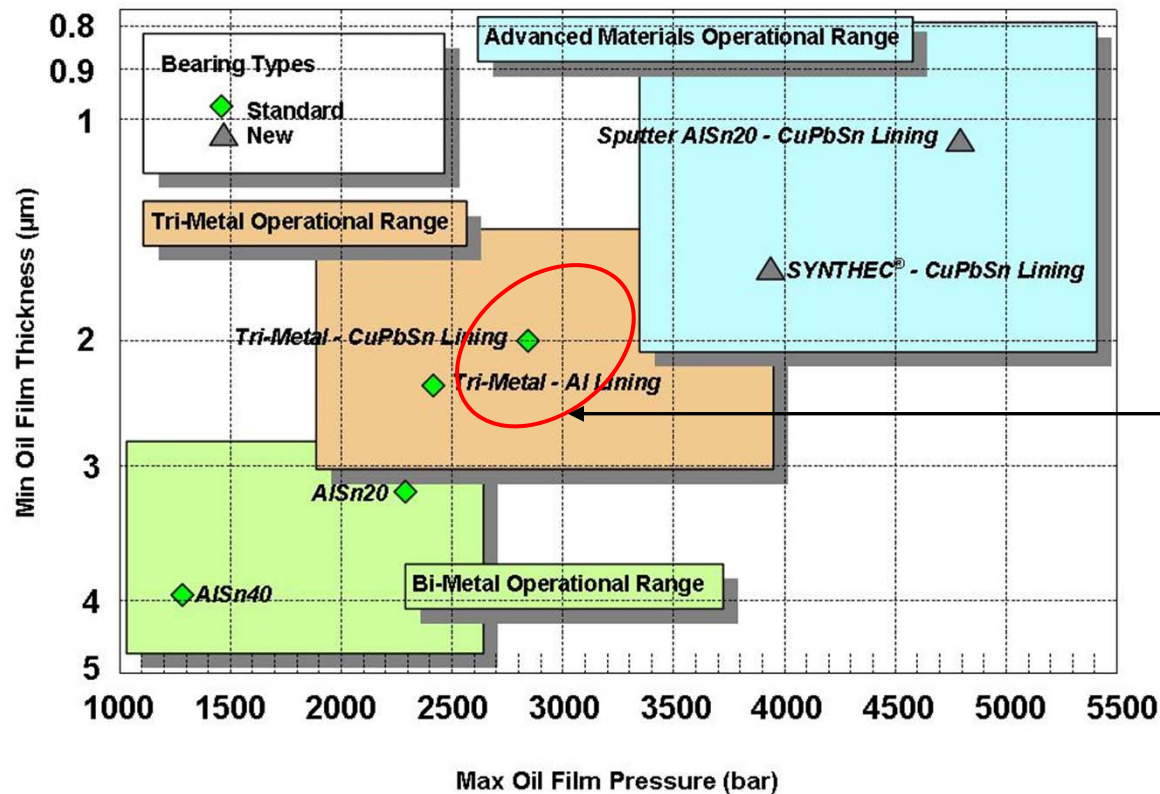
Bearing Materials

- Steel Backed Leded Bronze Tri-metal bearings are the default material choice for compressor rod bearings. Given that MOFT range from roughly 2.0-3.0 and MOFP averages around 3000 bar on the rod bearings.
- Bi-metal Aluminum lined bearings are sometimes used. However, these are mainly for sour gas (H_2S) applications that will destroy the leaded bronze bearings.
- The main bearings see much less loading than the rods (only about 25-30%).

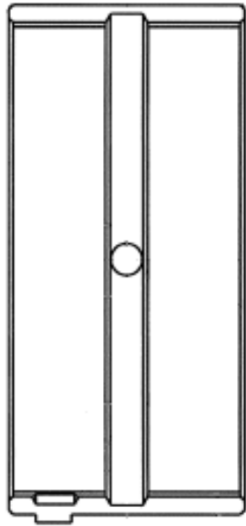
Improved oil feed - NP vs. current style

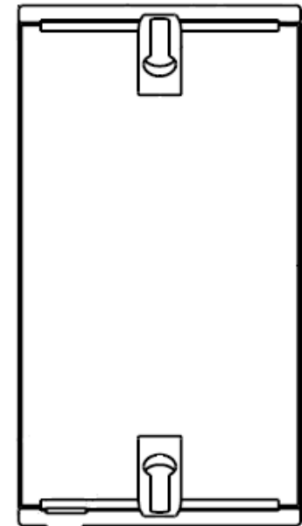
New - NP

- leverages experience from other GE recip products
- Double oil feed / bearing
- Removed circumferential groove at high load
- increased pin width
- improved manufacturing local geometry at crank wall

- New Babbitt (Synthec) bearing option for increased margins
- New NP-style dual feed for significant margin improvement to new units

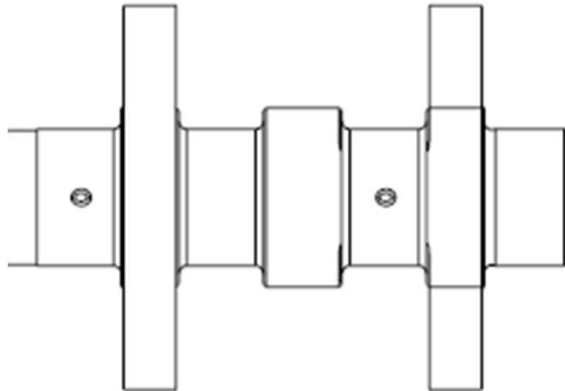
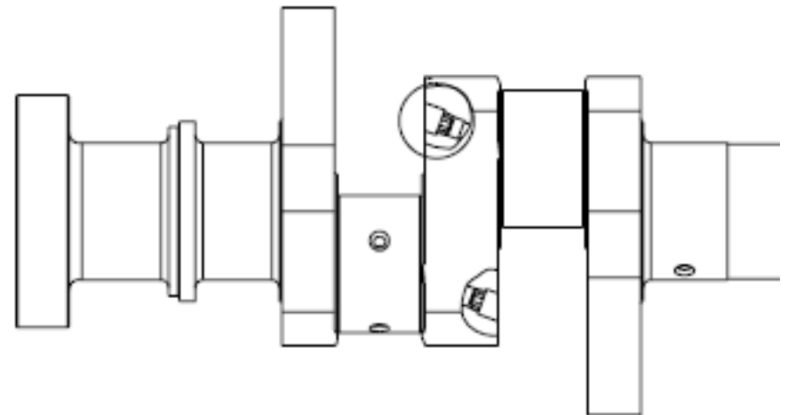
Proposed Changes – NP Style Bearing

Comparison of Standard Bearing vs. NP Style HD Plots.

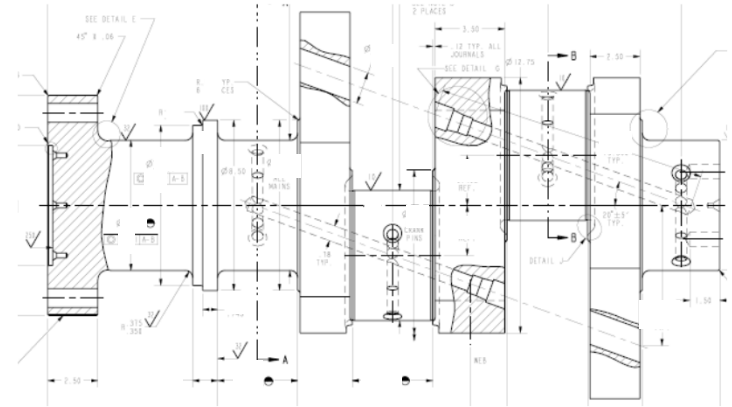
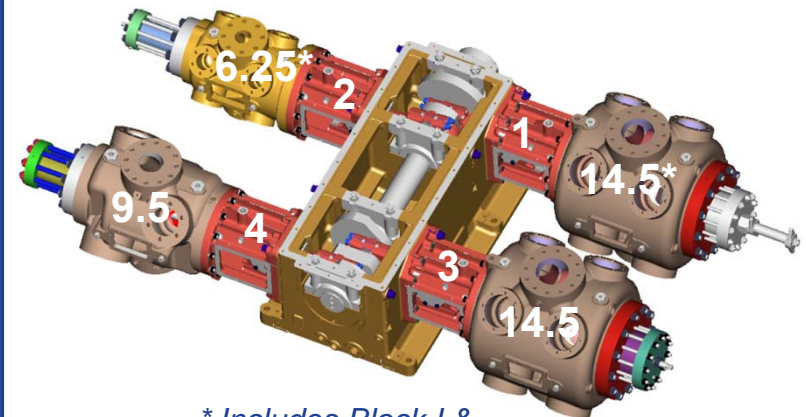
DEF Block Change Test

Scope of design change

- Widen crankpin to big-end bearing contact surface to enhance the lubrication behaviour and achieve a higher degree of reliability

- Crankshaft
- Crank pin bearing
- Connecting rod

Instrumentation
